# A Sure Foundation

## Comparing the Jule Frame to the Healey Original

by David Selb,  
Niagara Frontier Chapter

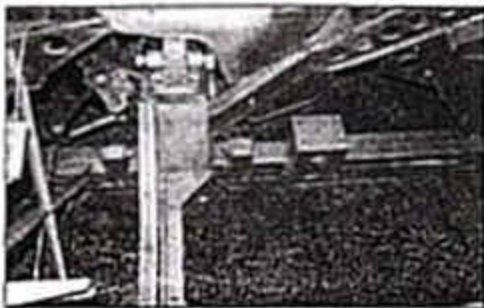
Right chassis rail capped. Good example of poor attempt to solve main rail compression buckling.

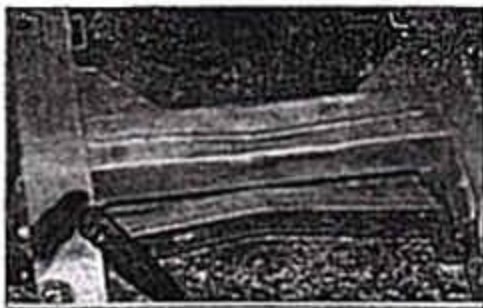
Split front cross member. Right control arm repair.

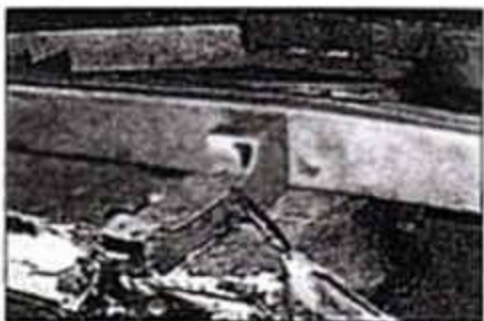
Buckling of left rail. Patching on right rail. Decayed front outrigger.

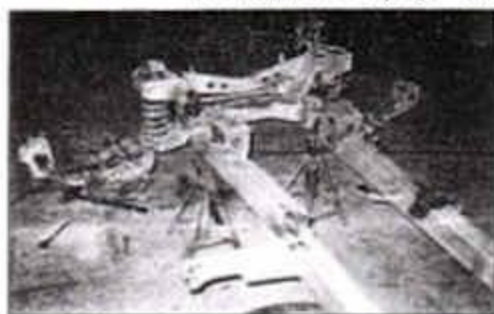
Shearing of left chassis rail just in front of outrigger.

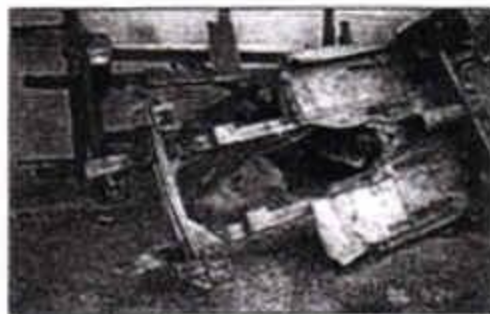
Discarded chassis. Notice chassis closest to wall Bottom rail capped with flat bar.

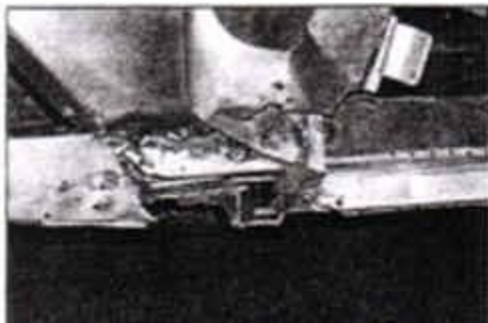
Common finding in lower front bulkhead corners.

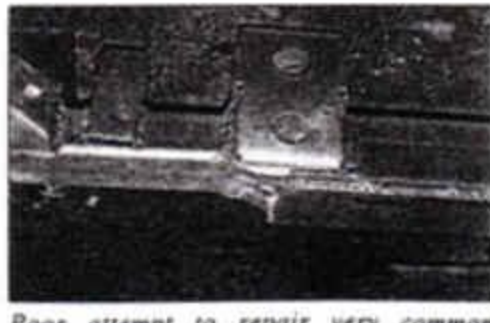
Poor attempt to repair very common problems with engine mount, control arm brk and chassis buckling.

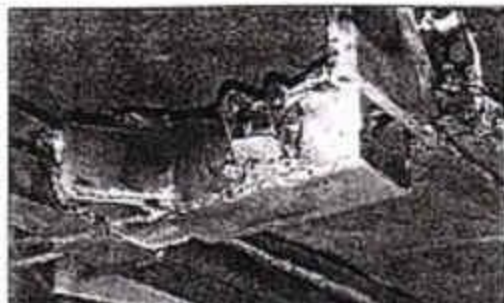
Typical rear outrigger repair.

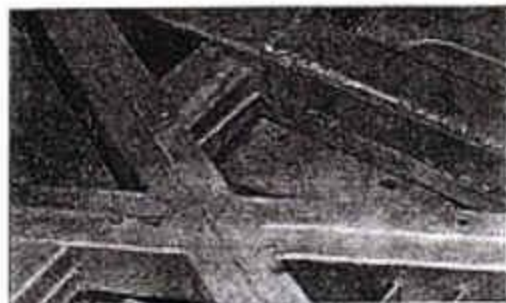
Rear outrigger repair.

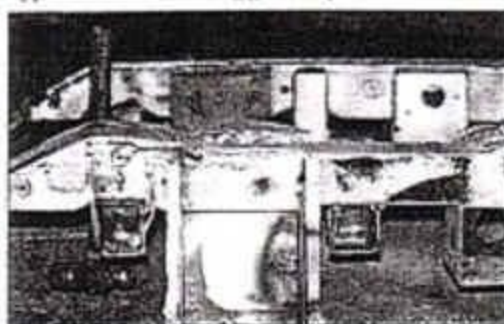
Front chassis repair. Notice 3x3 tube sectioned in.

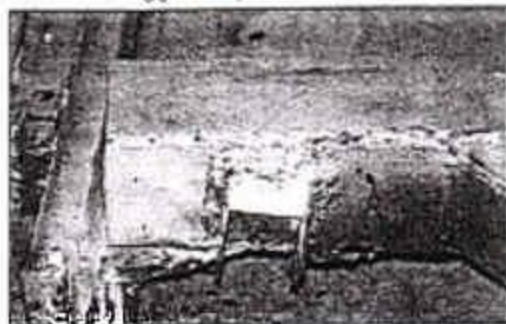
Lower rail repair.
