A SURE FOUNDATION **THE FOLLOW-UP ARTICLE**

By David C. Seib

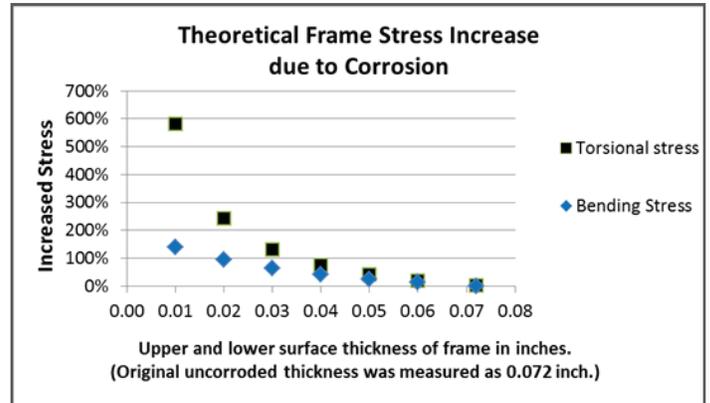
Corrosion of the upper and lower main frame rail surfaces causes increased stress on the remaining metal. Text book calculation of increased stress due to an equal amount of thinning of the upper and lower main frame rail surfaces was performed. Realize that a simple calculation of this type is limited in its capability, and is presented only as an example to better understand the effects of frame

degradation. This calculation is not intended to imply a degree of deterioration that is safe. Each owner has to assess their own car by their own standards. The calculated points do indicate that torsional stress rises faster than longitudinal bending stress as a result of upper and lower frame surface thinning. The amount of stress increase starts slowly and as metal removal increases the stresses rise rapidly. Realize that at a 100% increase in stress the remaining metal of the main frame rails is handling twice the stress of the original Healey design. Mr. Healey's originally calculated safety margins for longitudinal torsion and bending stress are unknown.
